NASA
Technical Paper 1810

Reasons for Low Aerodynamic Performance of 13.5-Centimeter-Tip-Diameter Aircraft Engine Starter Turbine

Jeffrey E. Haas, Richard J. Roelke, and Paul Hermann

MARCH 1981

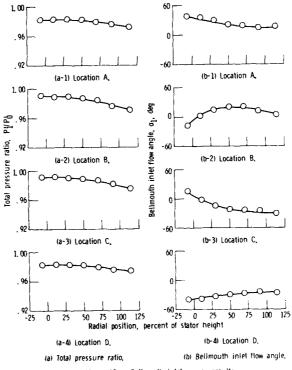
Figure 12. - Bellmouth inlet survey results.

Figure 12 shows that the bellmouth-inlet- to manifold-inlet-total-pressure ratio was about 0.98 around the circumference. Because the flow entering the manifold impacted the elbow section before being turned 180° into the stator (fig. 1), about 50 percent of the velocity head was lost. In addition, the total pressure ratio decreased from the hub to the tip at each circumferential position. This trend was

Also indicated by figure 12 is a circumferential variation in the level of total pressure. The total pressure ratio was about 0.5 percent higher near the bottom of the manifold (locations B and C) than at the sides (locations A and D). Although this trend was unexpected, the amount of variation was considered small and no further investigation of this trend was made.

Figure 12 also shows a wide radial and circumferential variation in the bellmouth inlet flow angle. Since the design bellmouth inlet flow angle was 0° , it is evident that the stator experienced incidence angles ranging from -40° to 40° . The effect of this incidence angle variation was expected to be small since the critical velocity ratio at the stator inlet was only about 0.2.

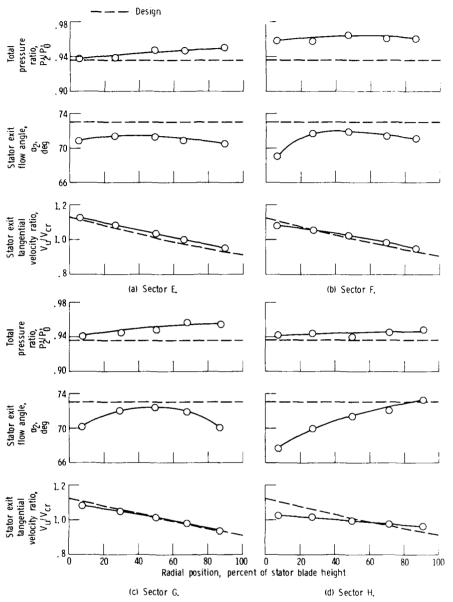
Figure 13. - Stator exit survey results.

The stator exit survey results are shown in figure 13. Test data obtained by the manufacturer indicated a high loss area near sector E (fig. 11). The stator exit surveys were made to determine whether this or any other major loss area existed.

As with the bellmouth inlet survey results the stator exit surveys indicated radial and circumferential variations in total pressure and flow angle. The highest total pressure was near the bottom of the manifold (sector F), which was consistent with the bellmouth inlet results. Arithmetically averaging the total pressure ratio and flow angle data resulted in values of 0.950 and 71°. The corresponding design values were 0.936 and 73°. The survey results at each circumferential position were used to calculate stator exit tangential velocity ratios, which are also shown in figure 13. The results indicated that the radial variations in tangential velocity ratio at the four survey sectors were close to the design intent. From the results shown in figure 13 it was determined that even though there were radial and circumferential

gradients in flow, no large loss areas existed in the stator.

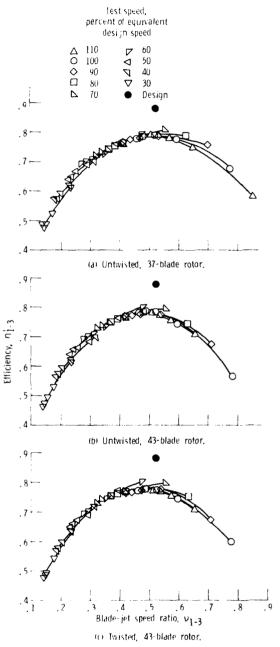
Figure 16. - Variation of efficiency with blade-jet speed ratio with constant-area exhaust duct installed and with open honeycomb shroud.

The performance results for the three rotor configurations with the constant-area exhaust duct and the original honeycomb shroud installed are shown in figure 16. Total efficiency, based on the bellmouth-inlet- to rotor-exit-total-pressure ratio, is plotted against blade-jet speed ratio. At design equivalent conditions of speed and blade-jet speed ratio, the total efficiencies were 0.786, 0.785, and 0.773 for the untwisted, 37-blade, the untwisted, 43-blade, and the twisted, 43-blade rotor configurations, respectively. These efficiencies ranged from 9.4 to 10.7 points lower than the design value of 0.88.

Both the manufacturer and the Lewis Research Center believed that the turbine efficiency would be higher with the untwisted, 43-blade rotor than with the untwisted, 37-blade rotor because of higher rotor solidity. Similarly, the highest efficiency was expected with the twisted, 43-blade rotor because of higher rotor solidity and more optimum rotor incidence. Figures 15 and 16 reveal that neither of these expectations was fulfilled. It is likely that the improvements that were expected were masked by the large loss mechanism that caused the turbine efficiencies to be considerably less than design.

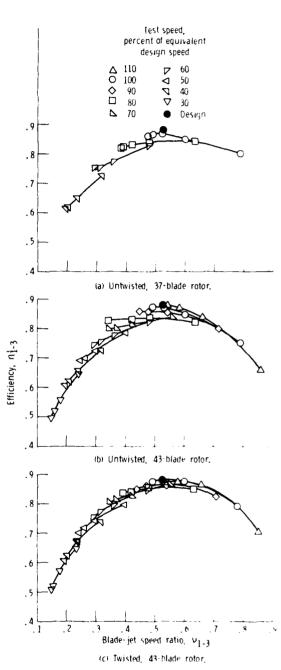
Figure 17. - Variation of efficiency with blade jet speed rate with constant-area exhaust duct installed and honeycomic shroud filled.

The dramatic improvement in turbine efficiency that occurred when the honeycomb shroud was filled is shown in figure 17. As before, turbine efficiency is plotted against blade-jet speed ratio. At design equivalent conditions of speed and blade-jet speed ratio the total efficiencies were 0.868, 0.871, and 0.883 for the untwisted, 37-blade, the untwisted, 43-blade, and the twisted, 43-blade rotor configurations, respectively. These efficiencies ranged from 8.2 to 11.0 points higher than with the honeycomb shroud unfilled. It is apparent that the open honeycomb shroud caused a massive loss mechanism to occur.

Comparing figures 16 and 17 shows that the largest efficiency improvement (11.0 points) occurred with the twisted, 43-blade rotor. This implied that the open honeycomb shroud degraded the stage performance more for this rotor configuration than for the other two rotor configurations. As shown in figure 18 a higher level of rotor reaction was obtained for the twisted rotor design than for the two

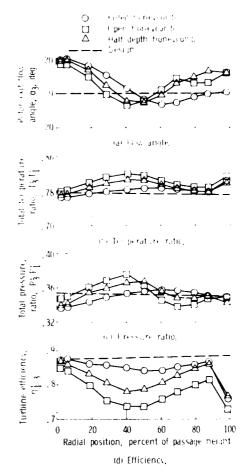
Figure 21. - Rotor exit survey results - untwisted, 37-blade rotor configuration.

Rotor exit radial surveys of total temperature, total pressure, and flow angle were conducted at design equivalent values of speed and blade-jet speed ratio to determine variations in blade element performance. Three survey probes were located downstream of the rotor at three different circumferential positions. The results from the probes were then arithmetically averaged. Figure 21 shows the averaged rotor exit survey results for the

untwisted, 37-blade rotor operating with each of the three shroud configurations. There are significant differences in the radial variations of the flow parameters among the three shroud configurations. The absolute levels of turbine efficiency calculated from the survey data (fig. 21(d)) are not as accurate as those based on the measured turbine torque, primarily because conduction made it difficult to obtain accurate total temperature measurements. However, the radial variations and relative levels of turbine efficiency calculated from the survey data are considered adequate to reveal significant differences in the blade element performance. These results show that the honeycomb shrouds affected not just the flow locally near the tip, but also the flow across the entire blade span. Figures 21(b) and (c) show that the radial variations in total temperature and total pressure were more nearly constant for the filled honeycomb shroud than for the two open honeycomb shrouds. The most dramatic efficiency improvement occurred with the filled honeycomb shroud as shown in figure 21(d). The efficiency for the filled honeycomb was higher across the entire blade span than that for the open honeycomb. The biggest difference was near the midspan, where a large loss area existed for the open honeycomb. For the half-depth honeycomb this midspan loss area was still present, although not as severe.

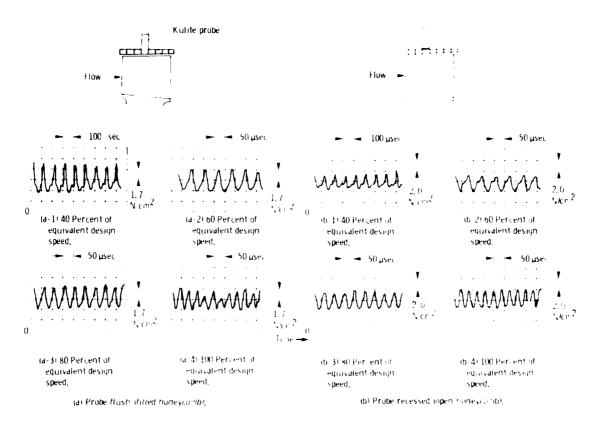
Figure 22. - Results of tests with pressure probe installed in honeycomb shroud of untwisted, 43 blade rotor,

Figure 22 shows that the magnitude of the peak-topeak pressures varied from about 40 to 60 percent of the average pressure. In addition, although the peakto-peak pressure values changed for both cases as speed changed, these pressure changes were small.

The following flow model was hypothesized on the basis of the results shown in figure 22: As the rotor blade passed by each cell in the honeycomb shroud, there was a rise in the static pressure. As a result a finite amount of gas flowed into the cell. After the maximum static pressure was reached, the pressure began to decrease, a sign that flow had exited the cell. The absolute velocity of this flow was normal to the mainstream flow direction. This flow out of the cell continued until the adjacent blade approached. This cyclic exchange of mass flow was repeated 43 times for each revolution of the rotor. The amount of gas

flowing into and out of the cells was theorized to be proportional to the cell volume and the average peak-to-peak pressure within the cell. The mass flow rate was then proportional to the amount of gas flowing into and out of the cells per passing blade and the blade passing frequency. Thus there was a trend of increasing mass flow rate with increasing rotative speed.

The gas being transported into and out of the honeycomb cells caused an efficiency loss. The transported gas lost kinetic energy in entering and leaving the cell. This flow reentered the primary mainstream with zero absolute tangential and axial velocity. Thus energy from the rotor and the primary mainstream was required to energize this fluid. In addition, the mainstream flow velocity was reduced in mixing with the transported gas, and thus a region of low-momentum fluid was formed, the effect of which was propagated radially and caused a large loss to occur over most of the blade height. The amount and extent of this loss would of course vary with the amount of transported gas. Thus, reducing the honeycomb cell depth or reducing the turbine rotative speed would reduce the performance deficit for an open honeycomb shroud.
